Manhole Inspection Summary

Manhole # S27E__034MH

Location Address: **816 SARATOGA ST**

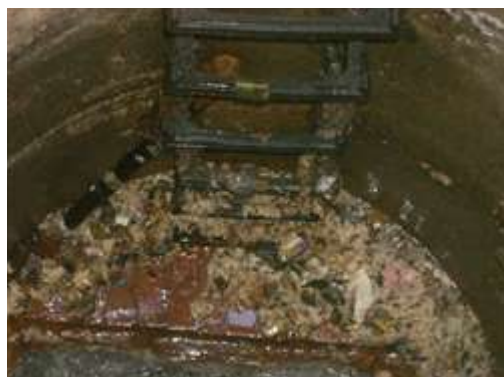
Defect 2

SURCHARGE EVIDENCE ON STEPS

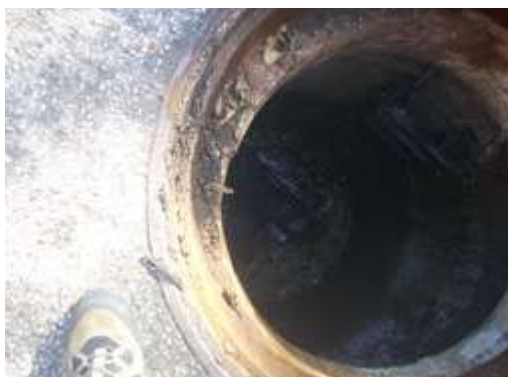
Defect 1

Offset: **2** (in.)

FRAME OFFSET

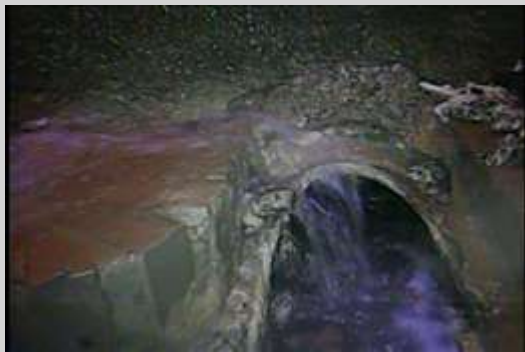
12 O'Clock Outflow

Pipe Height: **7.2** (in.) Rod and Bar (Angled)
Pipe Material: **Clay** ☐ Pipe Lined
Invert Depth: **10.80** (ft.) Flow Characteristics: **Slow**
Deposits: ☒ None ☐ Mud ☐ Sludge ☐ Debris ☐ Grease
Silt Depth: (in.) Deposits Extent:
Infiltration: **None** Pipe Seal Cond: **Sound**

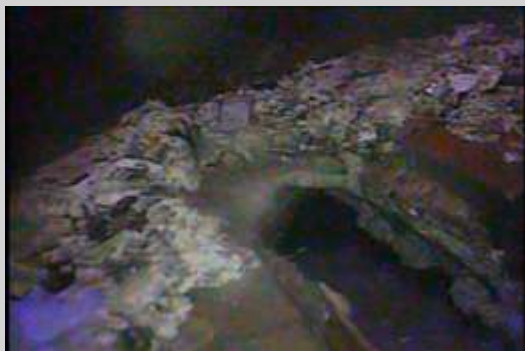
6 O'Clock Inflow

Pipe Height: **7.2** (in.) Rod and Bar (Angled)
Pipe Material: **Clay** ☐ Pipe Lined
Invert Depth: **10.68** (ft.) Flow Characteristics: **Slow**
Deposits: ☒ None ☐ Mud ☐ Sludge ☐ Debris ☐ Grease
Silt Depth: (in.) Deposits Extent:
Infiltration: **None** Pipe Seal Cond: **Broken**

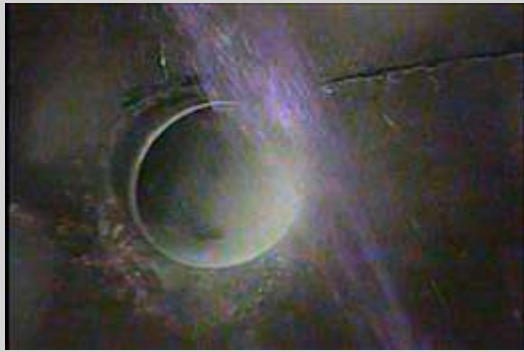
9 O'Clock Inflow

Drop: **Outside** Rod and Bar
Angled: **Yes** Reading: **9.60** (ft.)
Inv Depth: **10.60** (ft.)
Drop Condition: **Open**

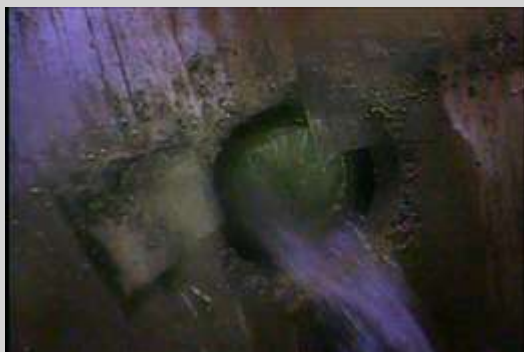
10 O'Clock Inflow

Connects To: **Connecting Node Not Available**
